**U.S. Department
of Transportation
Federal Highway
Administration**

**LTPP Seasonal Monitoring
Program
Site Monitoring Suspension
Status Report
Section 510113, Danville
Virginia**

SMP SITE MONITORING SUSPENSION STATUS REPORT

VIRGINIA SECTION 510113

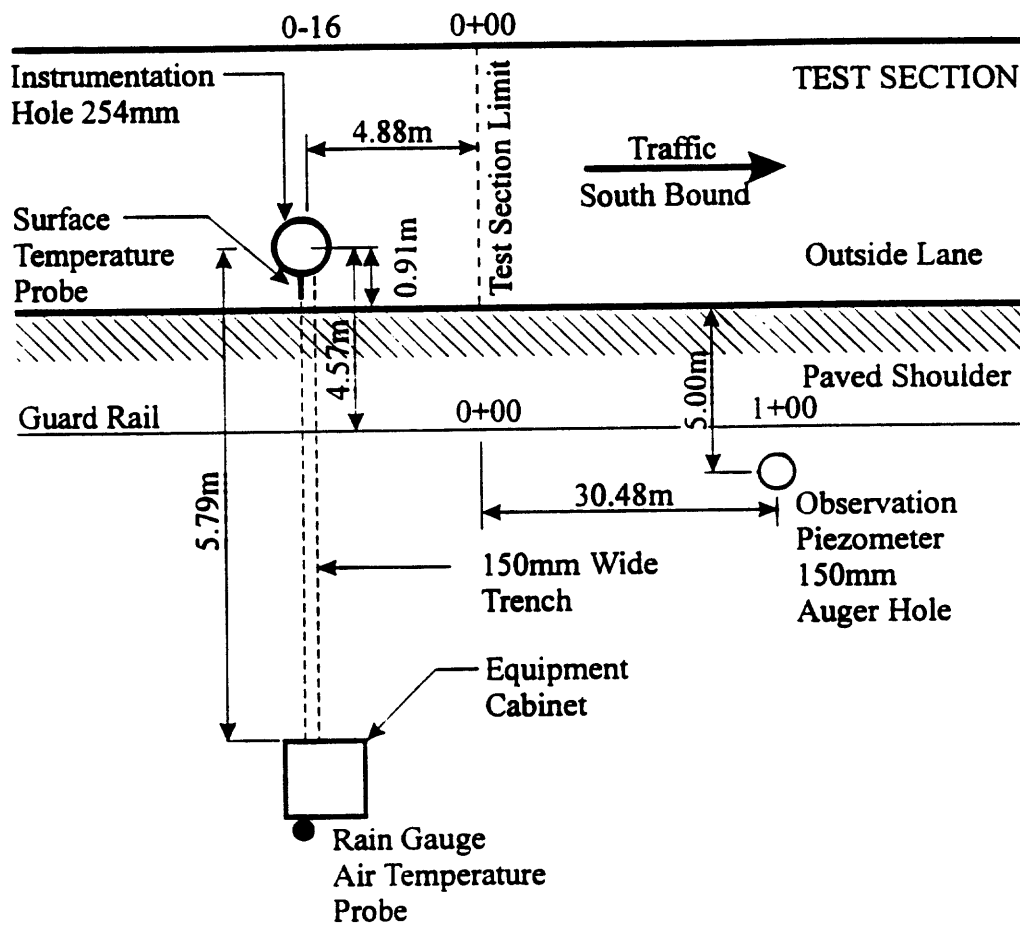
Figure 1. Location of Seasonal Monitoring Instrumentation Installed at SPS 510113

Figure 1 shows the locations of the installed instrumentation at the site. The instrumentation hole is at station 0+16 and the piezometer is at station 1+00. Table 2 gives elevations of the portion of Section 510113 that was used for elevation measurements. All offsets are from the PK nails found at the outside pavement edge.

- Height of Air Temperature Probe: 3.18m
- Height of Tipping Bucket Rain Gauge: 3.20m
- Depth of Piezometer: 4.27m

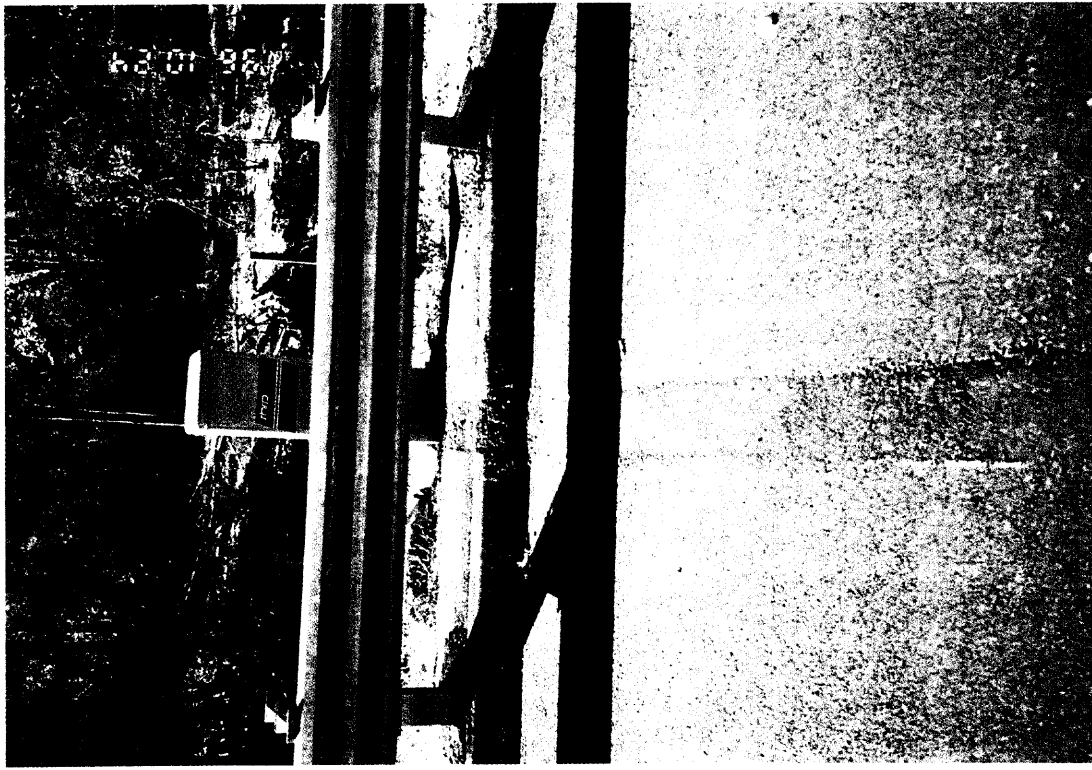
Instrumentation Trench to Equipment Cabinet,
Seasonal Site 510113, October 1996

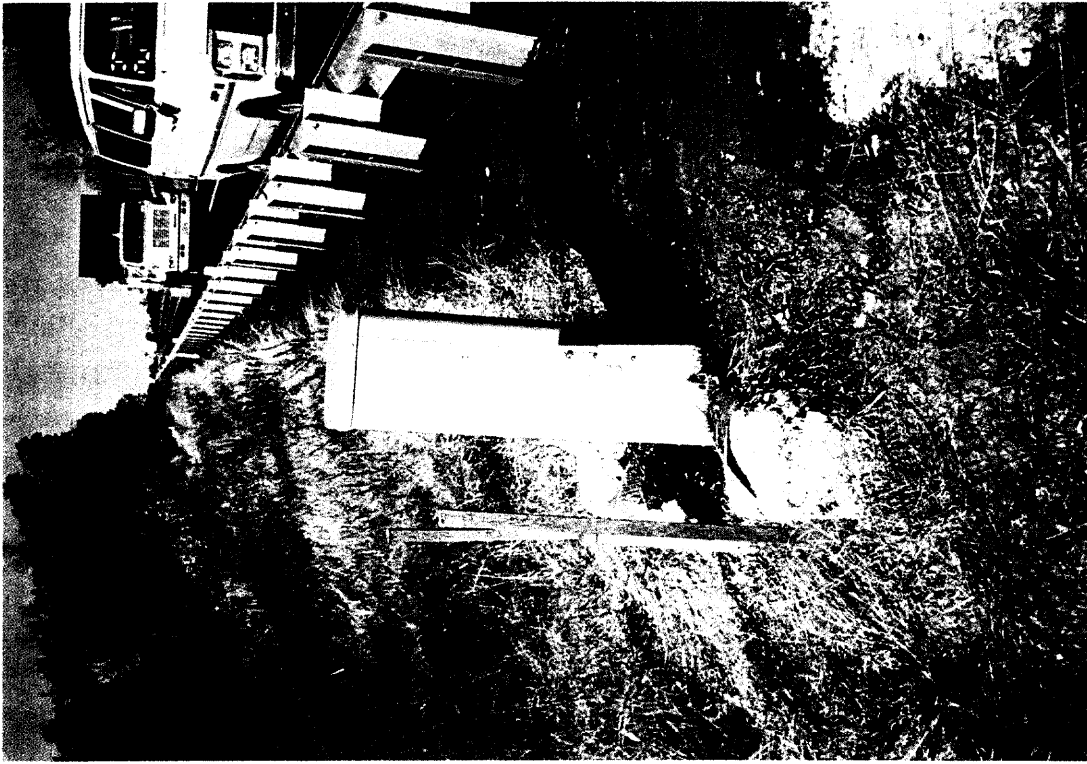
Equipment Cabinet, Seasonal Site 510113,
October 1996, After Suspension Activities

All the necessary suspension activities were completed on October 24, 1996. The dismantled equipment was removed from the site. The suspended site contains all the underground instrumentation, equipment, and an equipment cabinet with all the cables. The equipment cabinet was locked before leaving the site. The site was cleaned and left in a condition such that the instrumentation could be easily accessed when site monitoring activities resume.
